Effects of Ultraviolet-C Radiation Exposure on Aircraft Cabin Materials

Stephen F. Yates¹, Giorgio Isella¹, Emir Rahislic¹, Spencer Barbour², and Lillian Tiznado¹

¹Honeywell Aerospace,
1300 W. Warner Road, Tempe, AZ 85285, USA

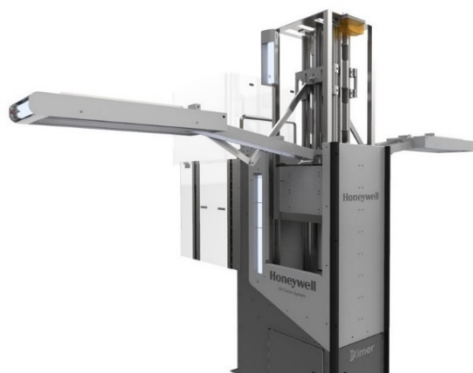
Fig. 1. Honeywell UV Cabin System.

Honeywell¹ has introduced a UV Cabin System (Fig. 1), which is composed of a base that is similar in dimensions to the beverage cart commonly used on aircraft and wings that are deployed to extend over the seats and are equipped with UV-C lamps.² The system is based on the “Germ Falcon” originally invented by Kreitenberg [10]. This system constitutes a significant improvement over handheld UV-C devices, since it reproducibly applies a known dose of light to each surface, determined by the intensity of the lamps, the distance between the lamps and the surfaces, and the exposure time. The latter is determined by the speed with which the operator moves the device down the aisle of the aircraft, measured by a speedometer on the device. The purpose of this study was to measure the dose incident on aircraft cabin surfaces from the UV Cabin System, and to determine the cumulative effect on aircraft materials of applying this dose.

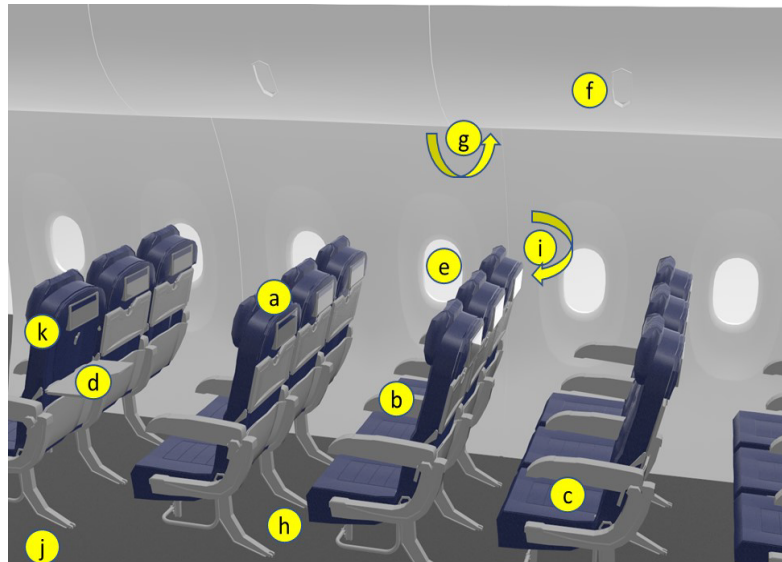
Fig. 2. Positions in aircraft cabin selected for dose measurements.

Samples of aircraft materials, including carpet, seat coverings, seat belts, decorative foil laminates, and plastics used for tray tables, *etc.*, were obtained from commercial suppliers or airlines. Table 2 shows the materials selected for this study. These samples were exposed to UV-C radiation using two Rayonet reactors (Southern New England Ultraviolet Co., Model RPR-100) equipped with 16 mercury vapor lamps arranged in a cylindrical space (Fig. 3). For flat or flexible materials, samples were taped to the exterior of a short length of polyvinyl chloride (PVC) pipe, which was positioned in the center of the reactor and slowly rotated during the length of exposure. The exposure time was determined by a Tork 457Z timer, which controlled the power to the reactor. A fan in the base of the reactor controlled the temperature to <30 °C. The liquid crystal display (LCD) screen samples were positioned on the base of the reactor at a distance from the UV lamps similar to that for the pipe. The intensity incident on the surface of the PVC pipe was measured by positioning our UV dosimeter (CureRight Radiometer, Model ILT800, International Light Technologies, in intensity mode) at the same distance from the lamps and recording the intensity facing each lamp and facing between each lamp and the next adjacent lamp. These values were averaged.

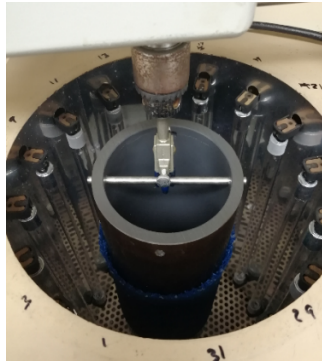
Fig. 3. UV irradiation system.

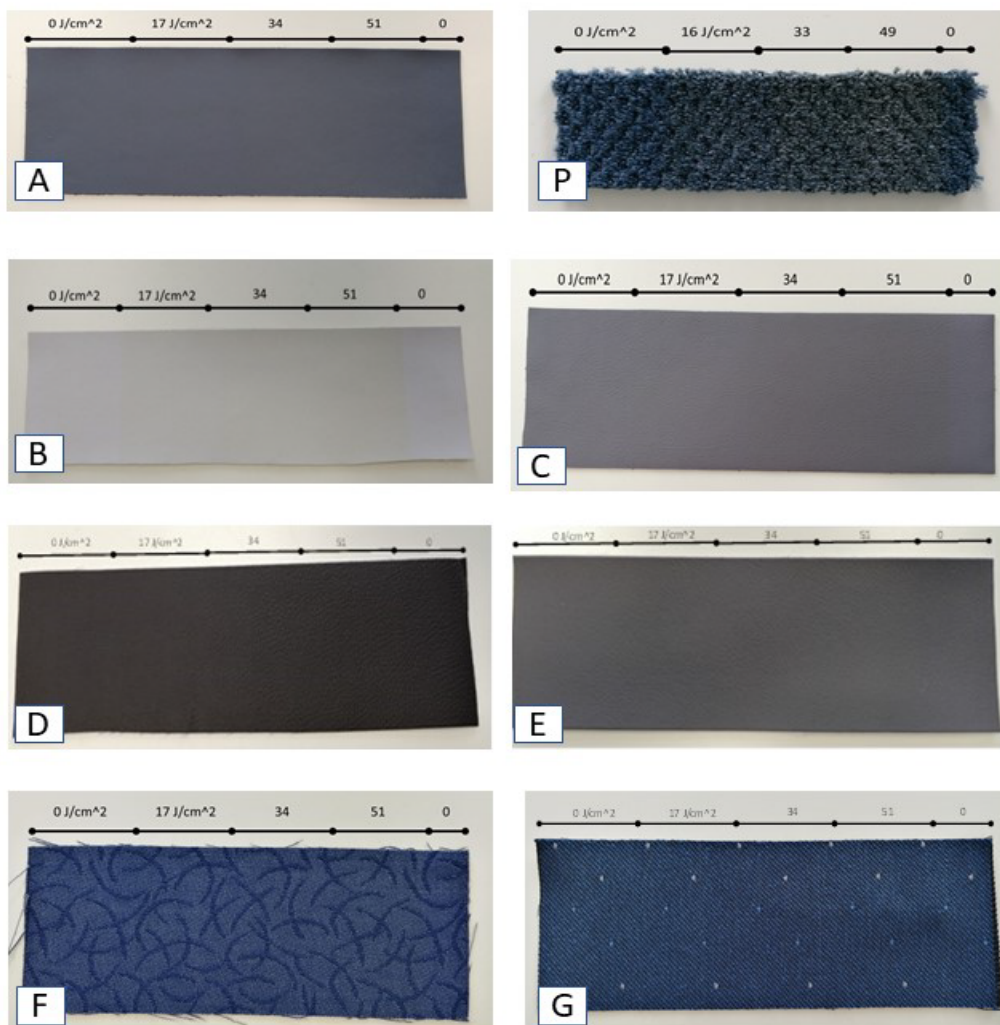
**Fig. 4.** Progressive color study photographs for carpet and seat-covering fabrics.

To evaluate the effect of UV-C on the appearance of materials, a study was completed on each. The materials were partially masked with tape, exposed to UV light, and then progressively unmasked. The effect is to create zones with different UV-C dose within the same sample. The samples were evaluated visually, and photographs of these samples were taken. Figure 4 shows photos of fabrics used for seat coverings and for carpet. Our inspection showed no apparent color changes for the leather seat covering A, or the two wool-polyester fabric coatings F and G. The nylon carpet sample P appeared a bit grayer after UV-C exposure. Of the four synthetic leather samples, two (D and E) had no apparent color change, while C was slightly yellowed at the highest dose. Sample B had a more visible yellow tinge at the highest dose. This may have been due to its lighter color.

The effect of exposure to UV-C radiation on the color or appearance of the materials tested was more significant. Darkly colored fabrics or materials generally did not show much color change, but white or light-colored materials became perceptibly faded or yellowed at the higher dose values. Of the seat fabrics, the wool-polyester blend materials and the leather appeared to be the most resistant to color change, while synthetic leather samples became slightly yellowed. Of the plastic materials, Boltaron 9815N, believed to be a polyacrylate PVC blend, was relatively sensitive to UV exposure, while polycarbonate was only slightly affected. Two of the decorative foil laminates (part numbers S016329 and S05051-011-H5) were marked as containing a heat-activated adhesive. In use, these laminates would be applied to a surface and heated to adhere. These two samples were also more sensitive to exposure to UV-C radiation. Since in practice the laminates will be exposed in place in an aircraft, these two samples are less representative.

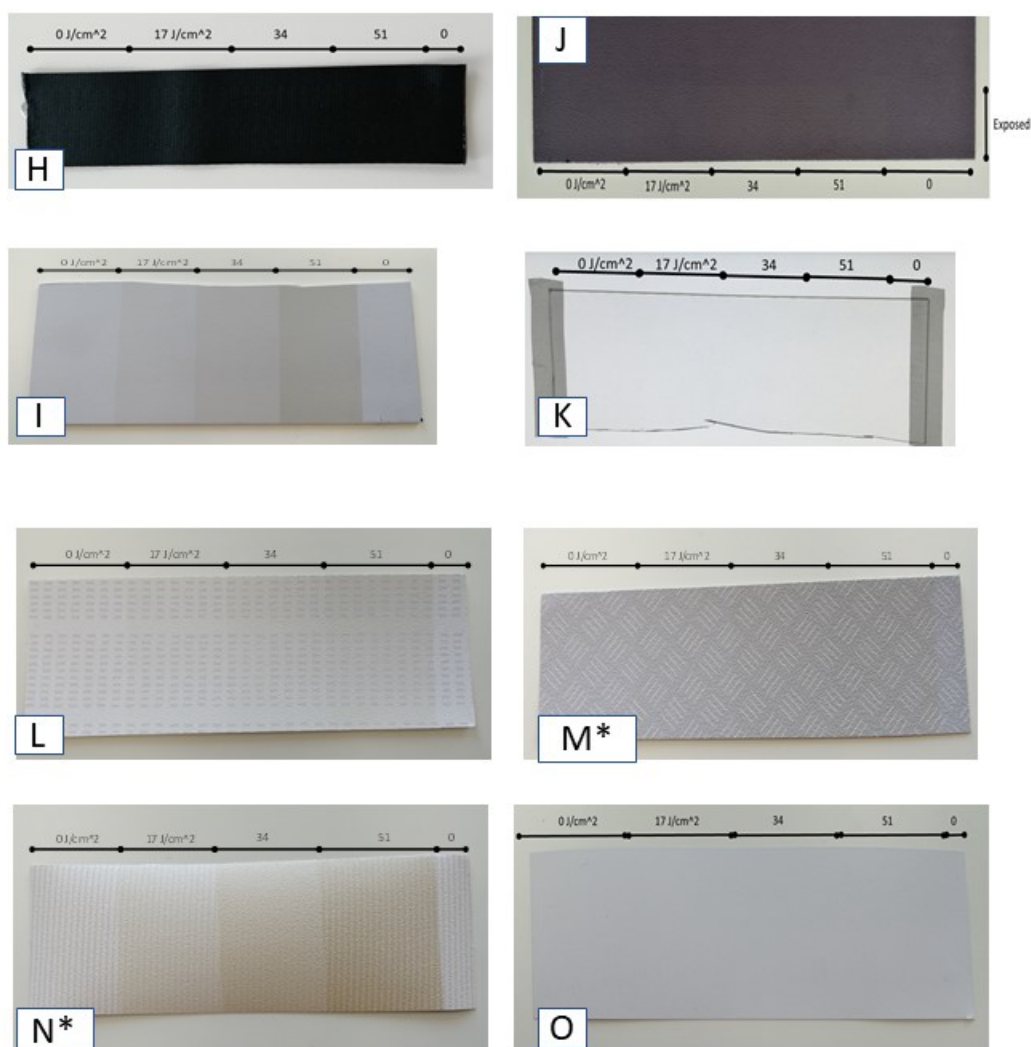
Fig. 5. Progressive color study photographs for other materials (seat belt, plastics, and décor foil laminates). Samples with * contained heat-activated adhesive.

Figure 5 shows other materials that were evaluated for changes in color. A black seat belt sample H showed no apparent change in appearance. Samples of plastics commonly used for tray tables, the bezels of in-flight entertainment screens, seat shells, and other uses were tested. A dark-colored sample of Kydex polyacrylate J showed no apparent change in color, but a light-colored sample of Boltaron 9815N was the most sensitive material tested to UV-C exposure, and it progressively yellowed with increasing UV-C exposure. The image of transparent polycarbonate K was photographed taped against a white illuminated screen for better visibility. A faint trace of yellow was seen at the highest dose. Decorative foil laminates are commonly used on aircraft walls or partitions, and four samples were evaluated. Samples L, M, and N showed some yellowing at the highest dose, with N, the most sensitive, showing discoloration at lower doses. Sample O had no apparent color change. On investigation, the two most sensitive samples, M and N, were marked as containing a heat-activated adhesive. In normal use, this adhesive would be used to apply the laminate to an interior surface in the cabin.

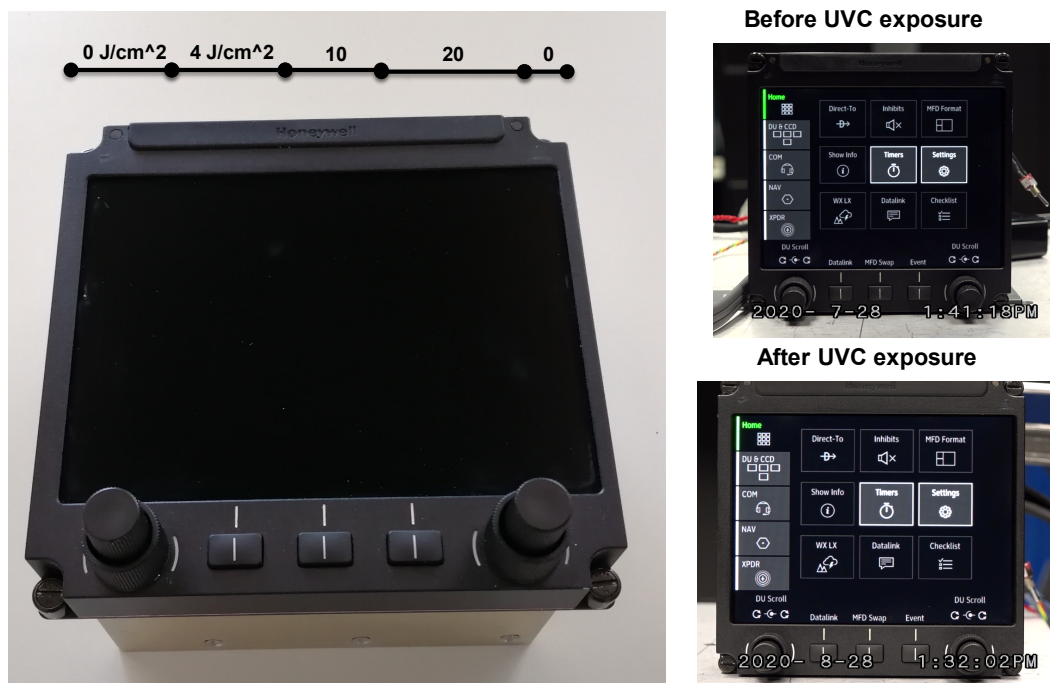
Fig. 6. Honeywell TSC 2.0 cockpit touchscreen display. Left: UV progressive doses. Right: Display before and after UV-C exposure.

Increasingly, aircraft cabins are equipped with LCD screens for in-flight entertainment and other uses. In the cabin, these may be mounted on the back of the seat in front of the passenger or on swing-out or fold-out mounts. Similar displays are used in the cockpit. A sample LCD screen in the form of a cockpit display was exposed to UV-C light in the same manner as with the progressive exposure experiments. Prior to this exposure, the monitor was activated, and after the exposure, the same display was again viewed. Figure 6 shows the results of the experiment. No discoloration or fading occurred for the bezel or other plastic components, nor to the screen itself. The screen continued to function, and, as the before and after photos reveal, there was no effect on the appearance of the display.
