Gulfstream G150 Flap/Slat Actuator Heater System STC

Peregrine Avionics

Summary

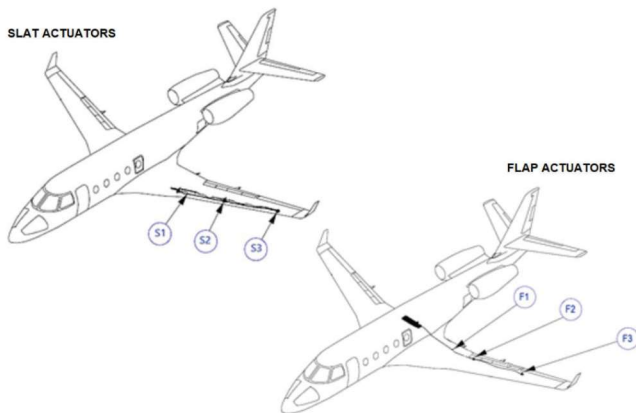
The G150 flap and slat drive system is composed of a Power Drive Unit (PDU), flexible drive shafts, and twelve linear ball screw actuators (3 per wing, 2 systems) as shown in Figure 1. The STC does not modify the G150 Flap/Slat drive system including controls, indications, safety mechanisms or recommended lubrication maintenance procedures. The existing Flap/Slat actuators are modified by the installation of external supplemental heaters only.

Figure 1: G150 Equipment Installation Locations, Left Wing Shown.
STC does not modify the G150 Flap/Slat drive system including controls, indications, safety mechanisms or recommended lubrication maintenance procedures

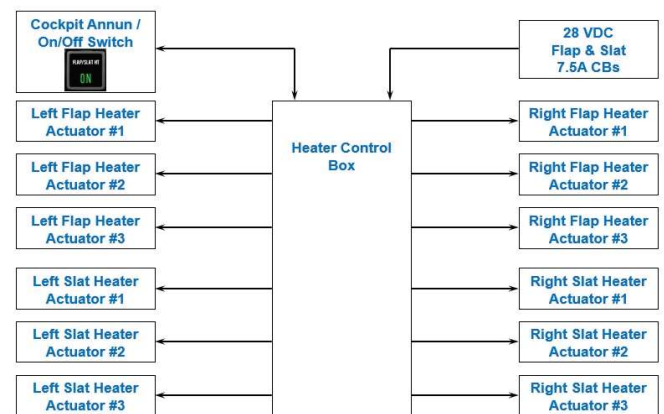
The Peregrine STC installation kit includes Peregrine-specific control and heater components. The Flap/Slat Actuator Heating System (FSAHS), when powered on by the cockpit ON/OFF switch, shown in Figure 2, is designed to automatically heat the actuator when temperatures are below 40° F. Thermistors installed on

each heater are used to both activate the heaters at the proper temperature and ensure the actuator never reaches the upper operating temperature limit of 130° F.

Figure 2: Heater Cuff System Overview

The Flap/Slat Actuator Heating Control Unit (FSHCU) has two separate sections (channels); one controls the six (6) flap actuator heater circuits while the other controls the six (6) slat actuator heater circuits. The controller will activate all of the heaters on a channel when any of the sensors on that channel read a temperature below 40° F. To prevent overheating actuators, if any of the channel

temperature sensor readings exceed 130° F the system will shut off the affected channel, even if another sensor is reading below 40° F. The system will remain shut off until a power cycle or self-test is initiated at the heater box.

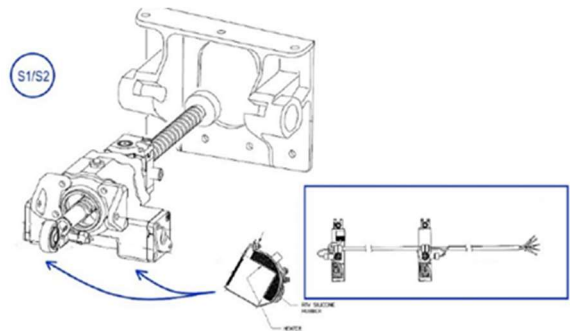
Figure 3: Wrap-around, cuff-style, design and are mounted on the exterior of the actuators

Gulfstream G150 aircraft can experience freeze-up of the slat or flap actuation system that can prevent their deployment during approach and landing phases of flight. The Peregrine STC covers the installation of wrap-around, cuff-style heaters (Figure 3), controls, monitoring systems and cockpit indications.
